Building Envelope Condition Survey Report

**Martha's Vineyard Regional High School
100 Edgartown Road
Oak Bluffs, Massachusetts**

May 29, 2015

RBA Project No. 2015037

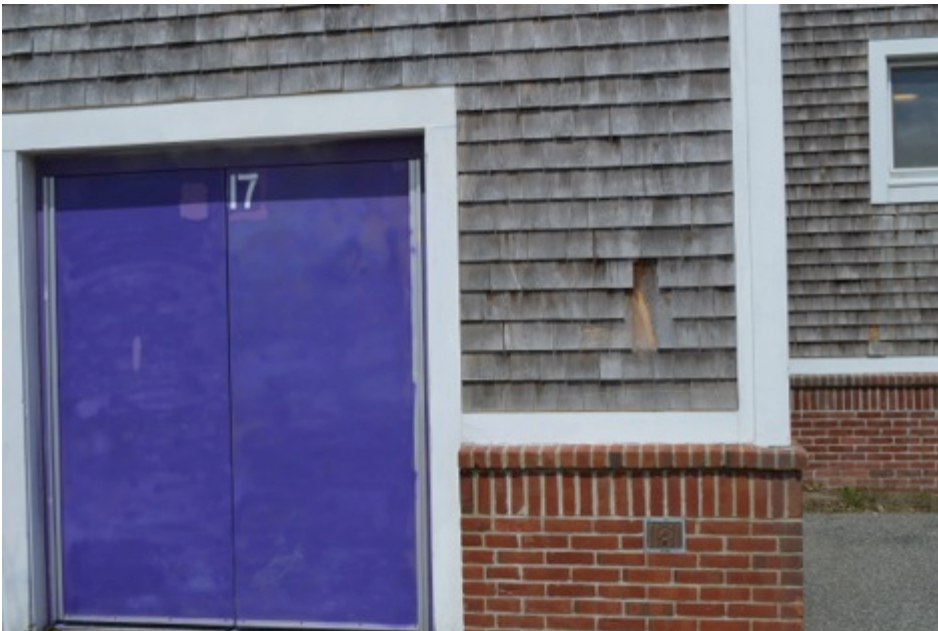
Photo No. 02

Missing/broken shingles.

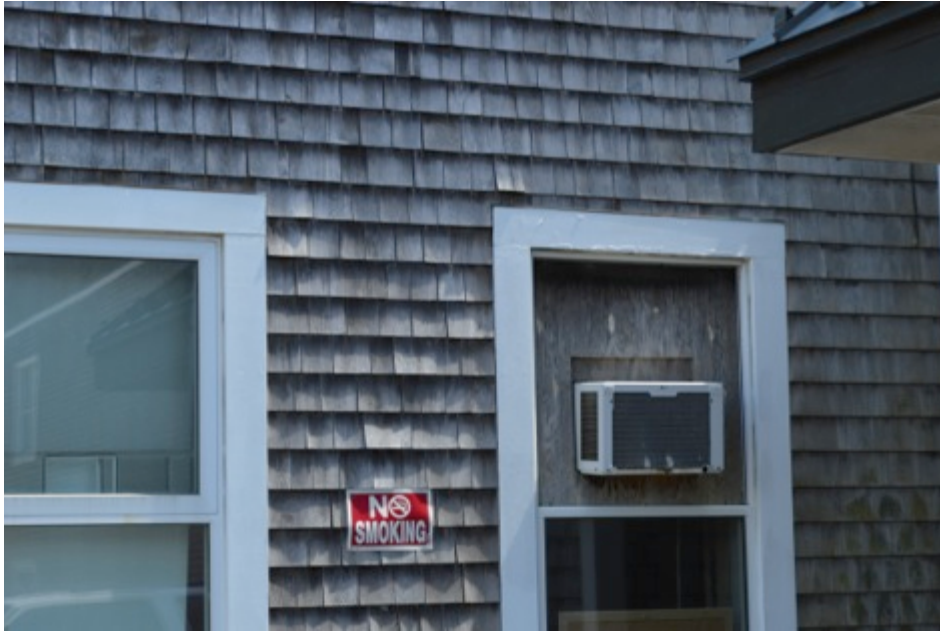
Photo No. 03

Improperly mounted air conditioner unit.

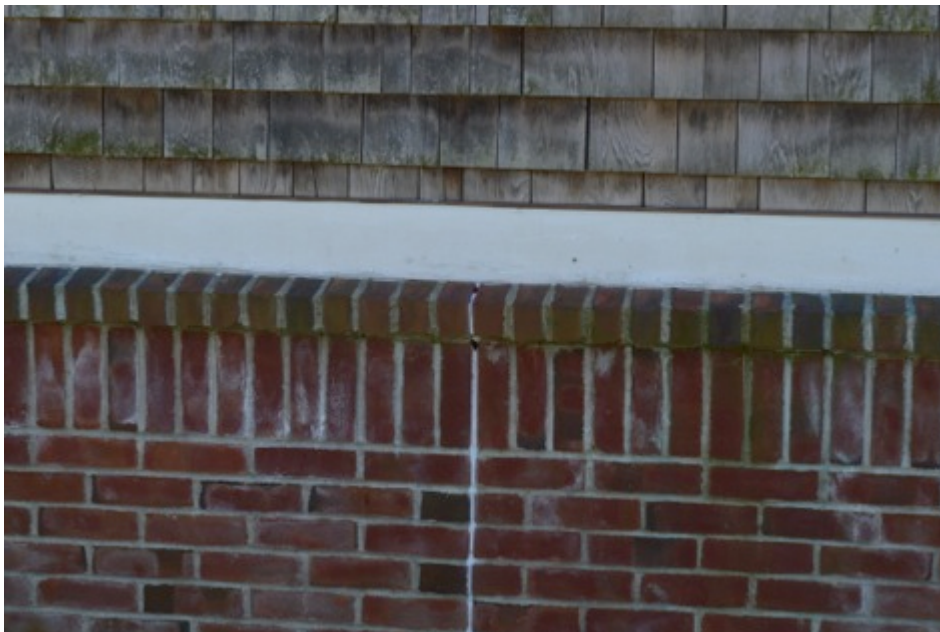
Photo No. 04

Failed sealant joint between brick & wood trim, & vertical control joint.

Typical failed mortar joint between top two rows of brick – on all walls that have both brick and shingle.

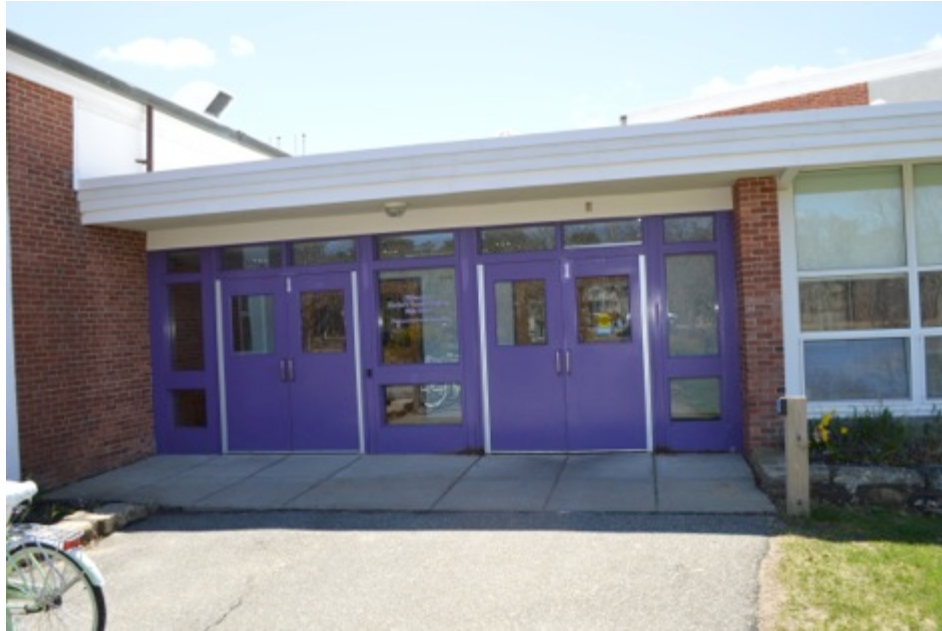
Photo No. 05

Rusted edges of windows and doors at main entrance.

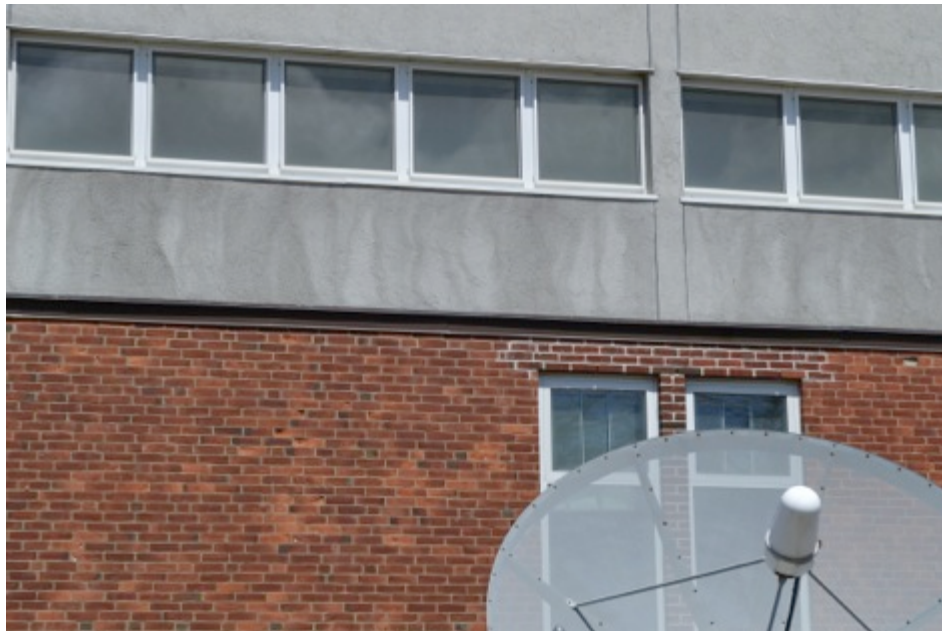
Photo No. 06

Apparent lintel repair at heads of windows (see lighter colored mortar).

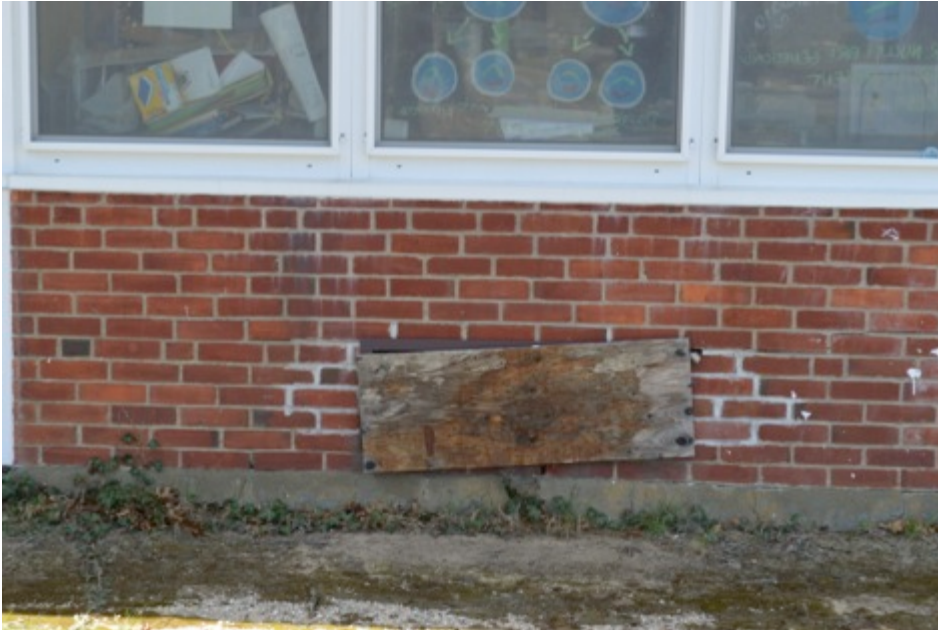
Photo No. 07

Louver in brick wall
boarded over.

Damaged brick.

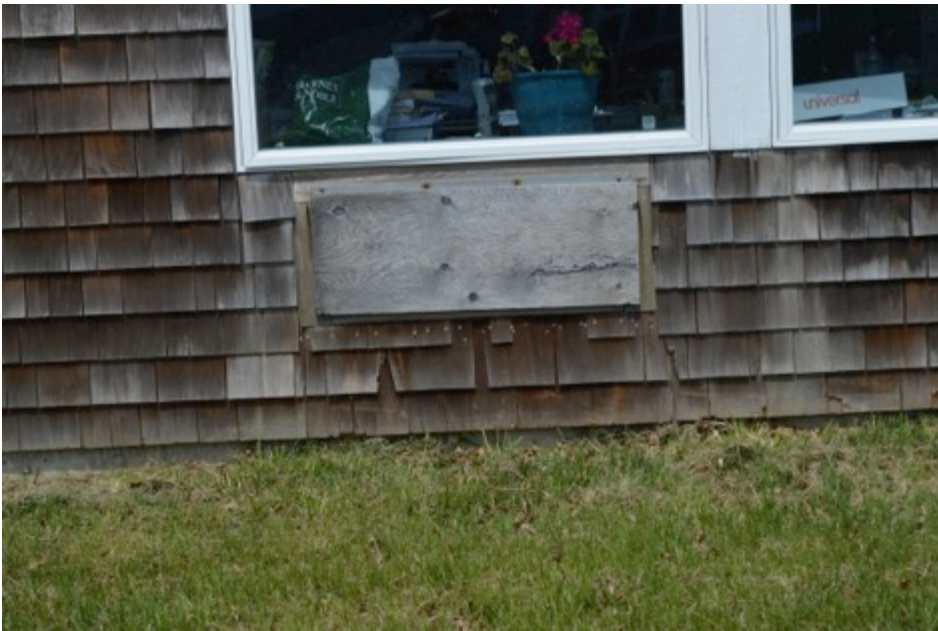
Photo No. 08

Louver in shingled
wall boarded over.

Damaged shingles.

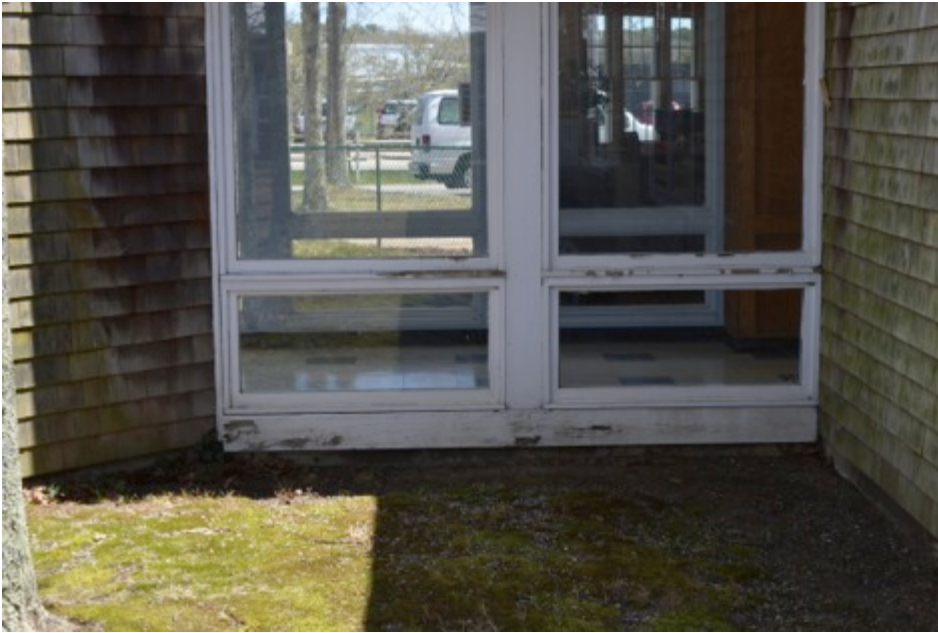
Photo No. 09

Chipped/peeling paint on most wood window frames and wood trim.

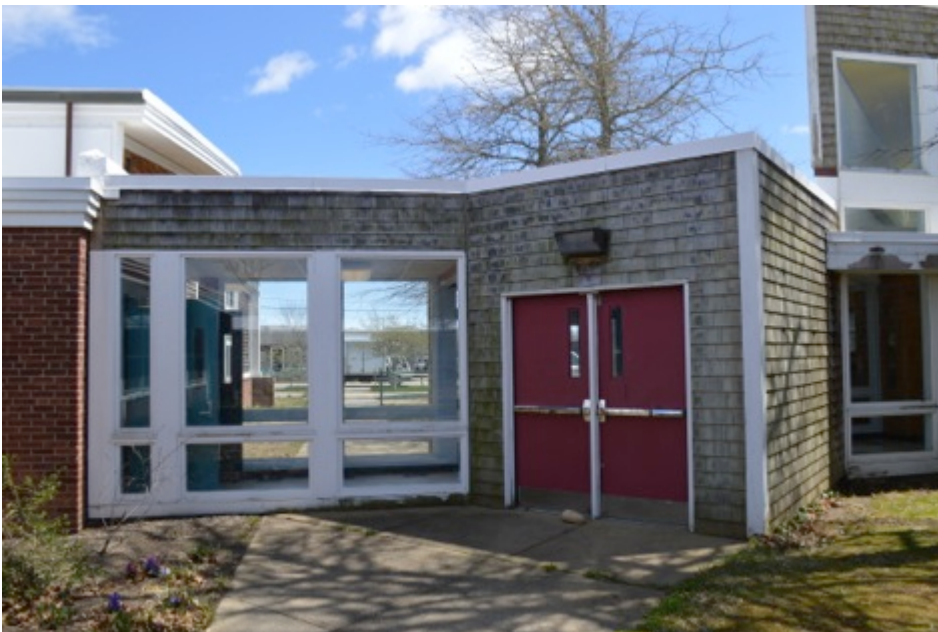
Photo No. 10

Failed paint at base of window.

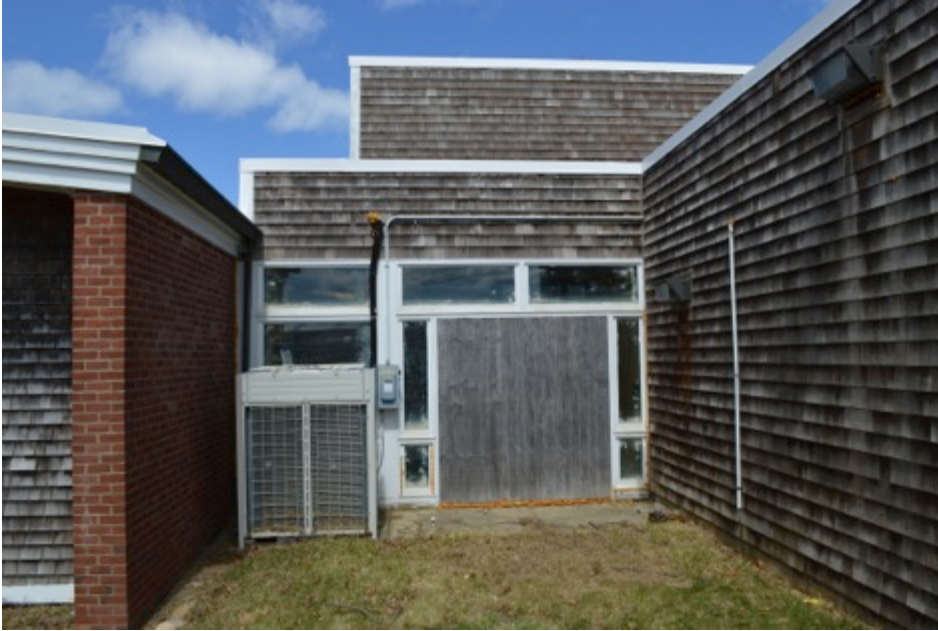
Photo No. 11

Door into larger courtyard enclosed and covered & sealed with plywood.

All glazing around door is cloudy and failed.

It is not clear if this door enclosure violates egress requirements.

Many of the existing doors are in good to fair condition with weather stripping repairs and hardware replacements required. Some door should be replaced entirely while some are in almost new condition. All should be repainted. The one courtyard doorway that has been enclosed should be investigated for emergency egress requirements and then should be reactivated or properly enclosed.

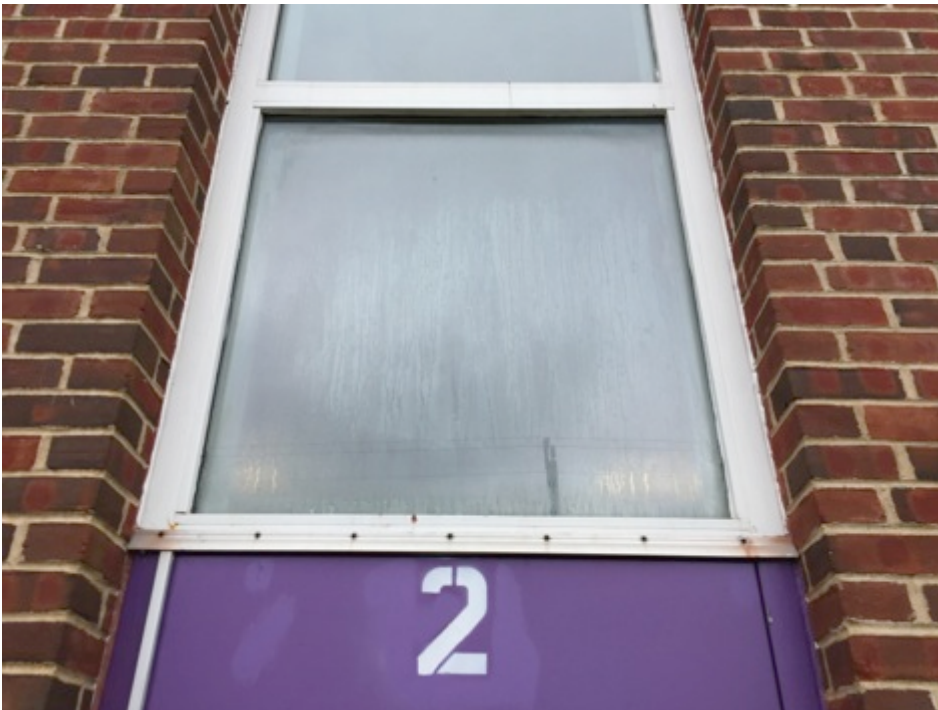
Photo No. 12

Cloudy/failed glazing with condensation drips on the inside.

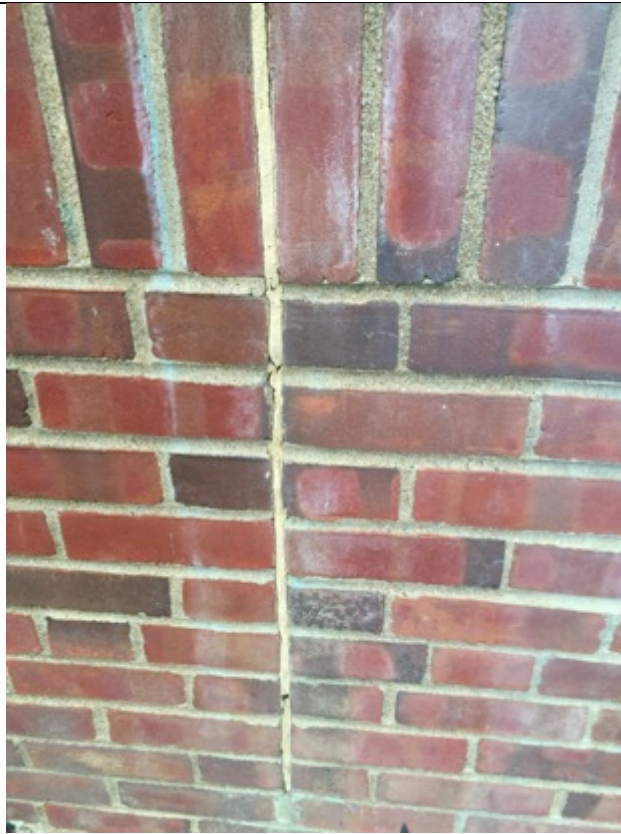
Photo No. 13

Close up of typical failed vertical control joint in brick wall.

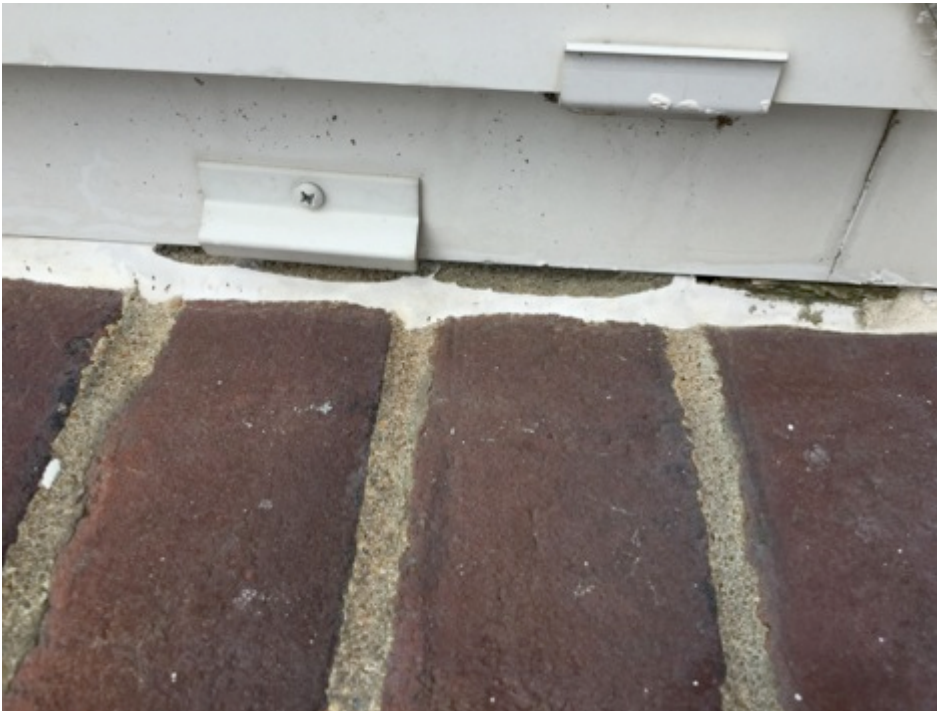
Photo No. 14

Typical failed sealant joint between window and brick sill.

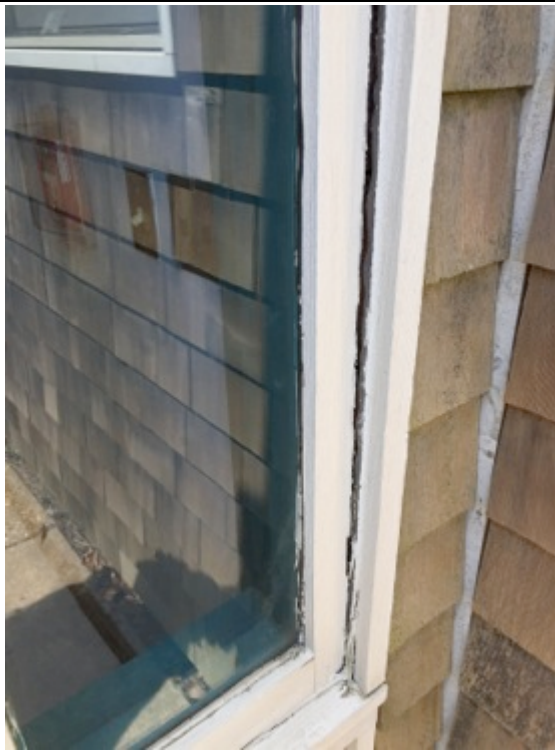
Photo No. 15

Typical failed sealant joint between window and wood trim.

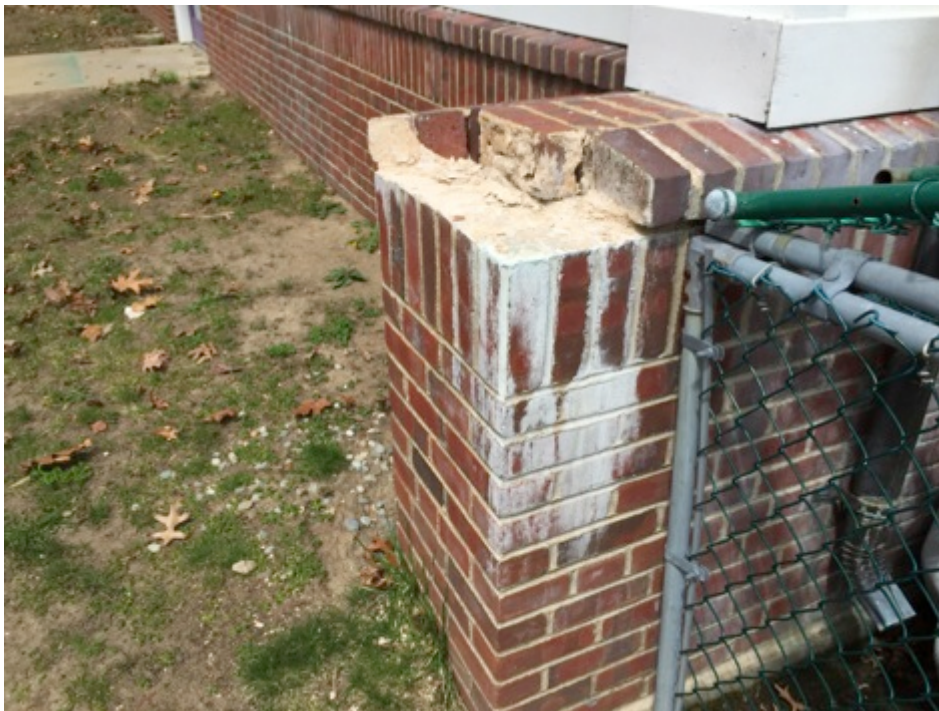
Photo No. 16

Broken and missing bricks on wall.

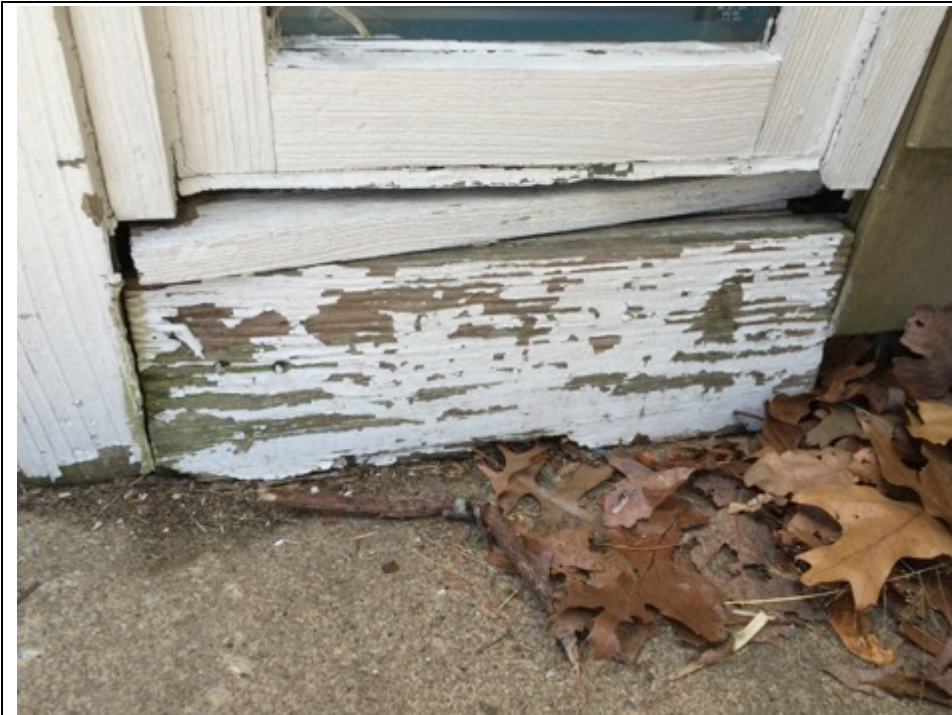
Photo No. 17

Pieces of wood window trim broken and dislodged, with chipped and peeling paint.

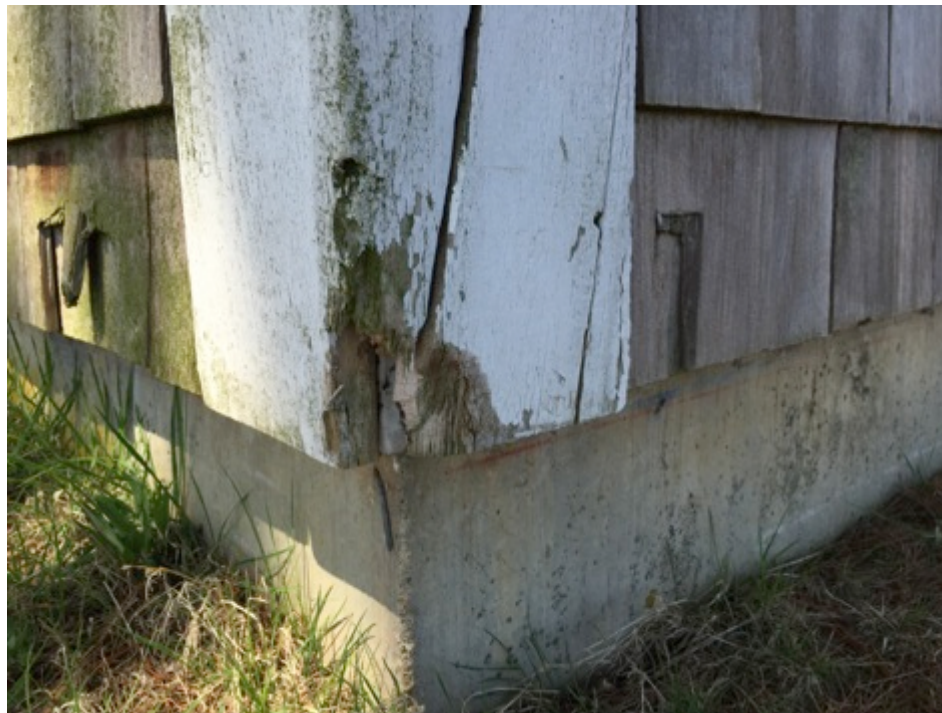
Photo No. 18

Broken and cracked cornerboard.

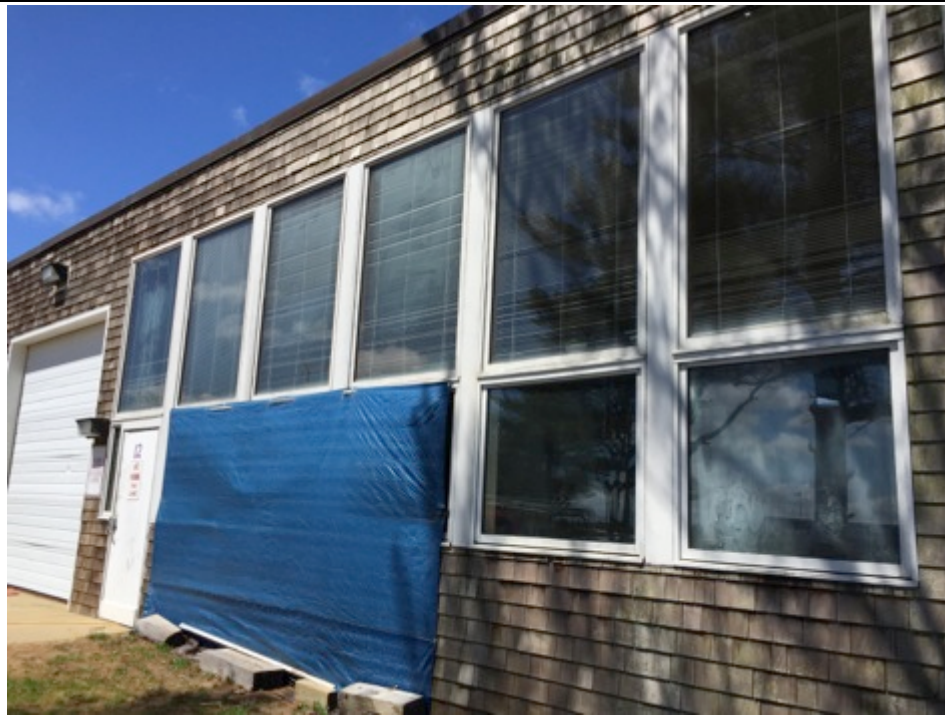
Photo No. 19

Missing and/or broken windows.

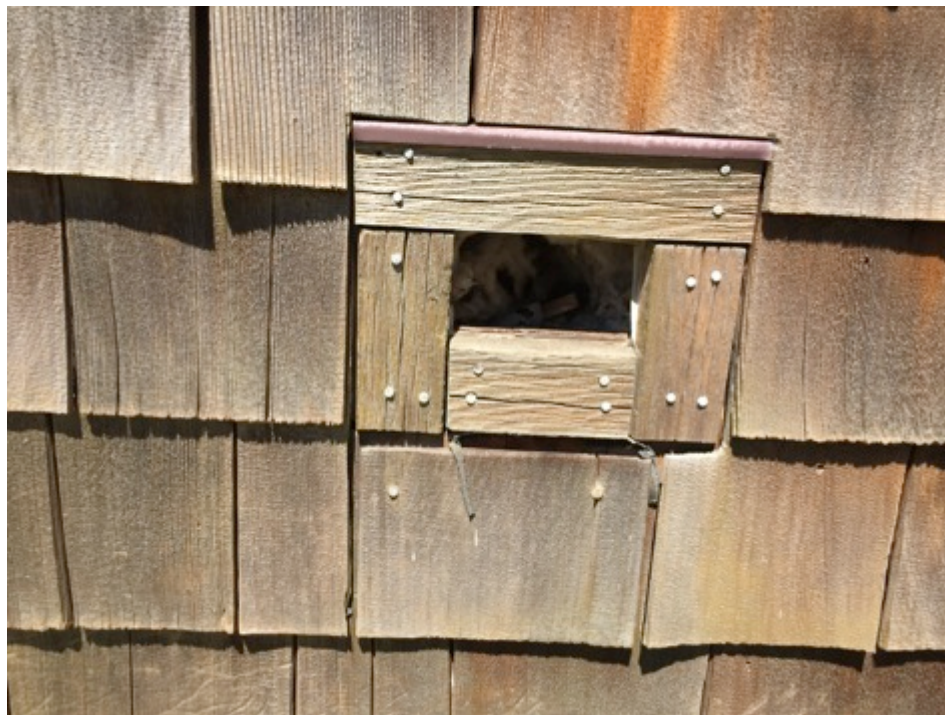
Photo No. 20

Open hole in shingled wall.

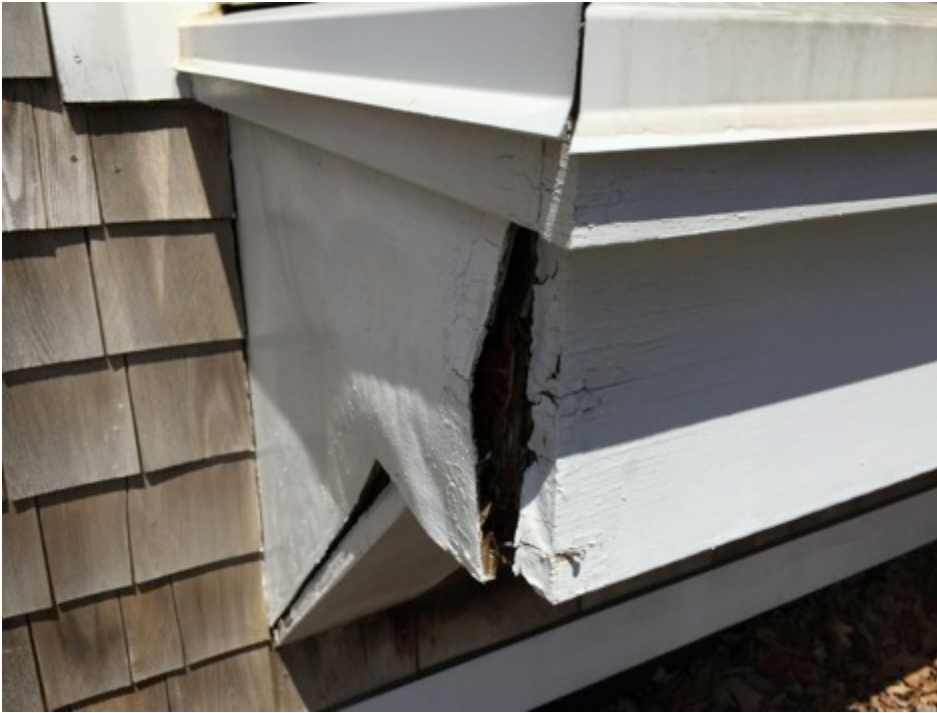
Photo No. 21

Wood trim around bay windows rotted and warped with screws sticking out. Brackets rotted.

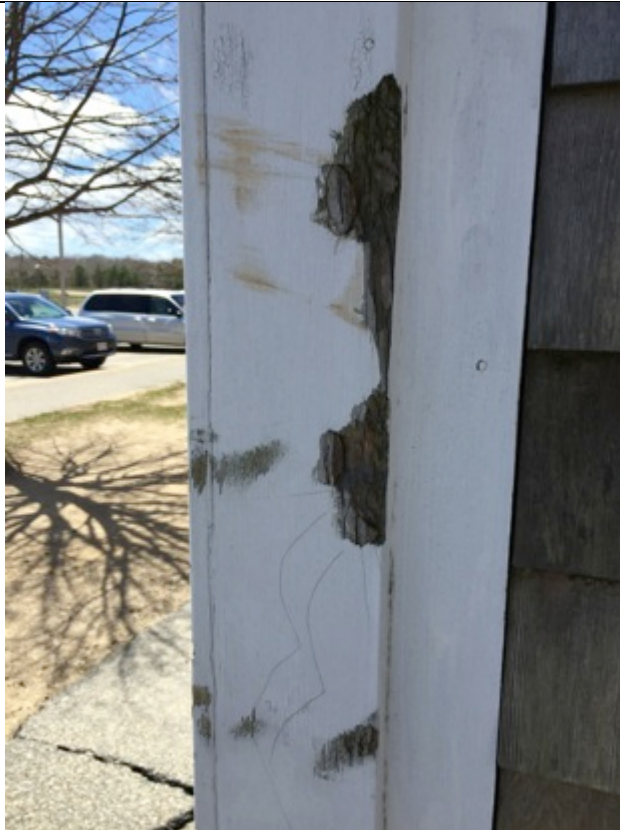
Photo No. 22

Wood corner board cracked and broken with missing paint and damage.

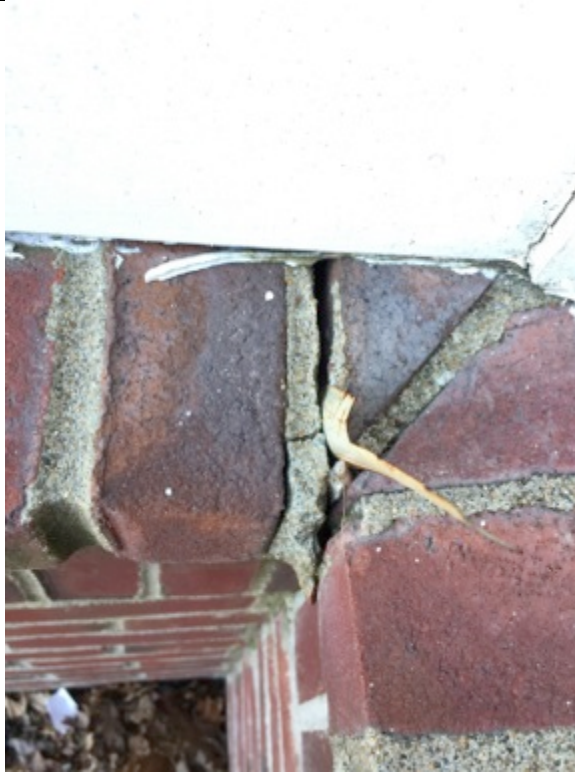
Photo No. 23

Typical cracked mortar between bricks.

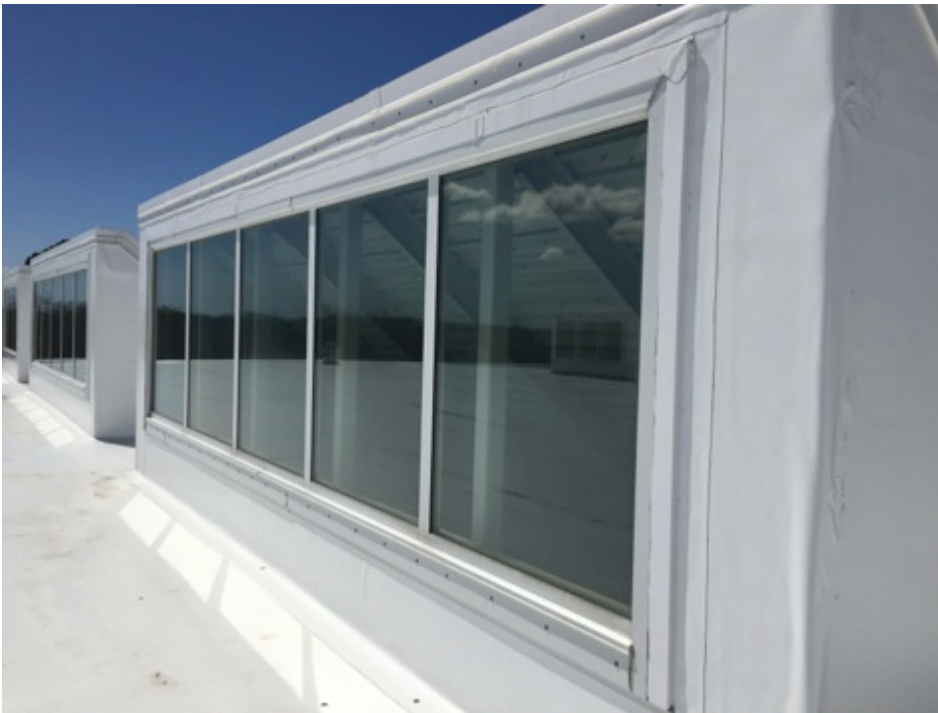
Photo No. 24

Failed joint at bottom of clerestory windows.

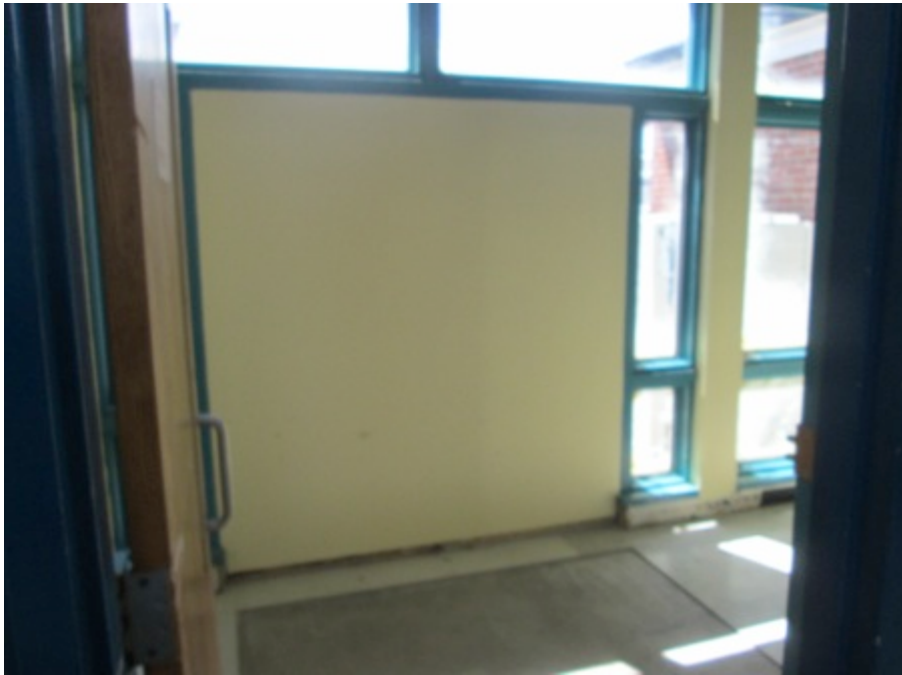
Photo No. 25

Interior of enclosed doorway.

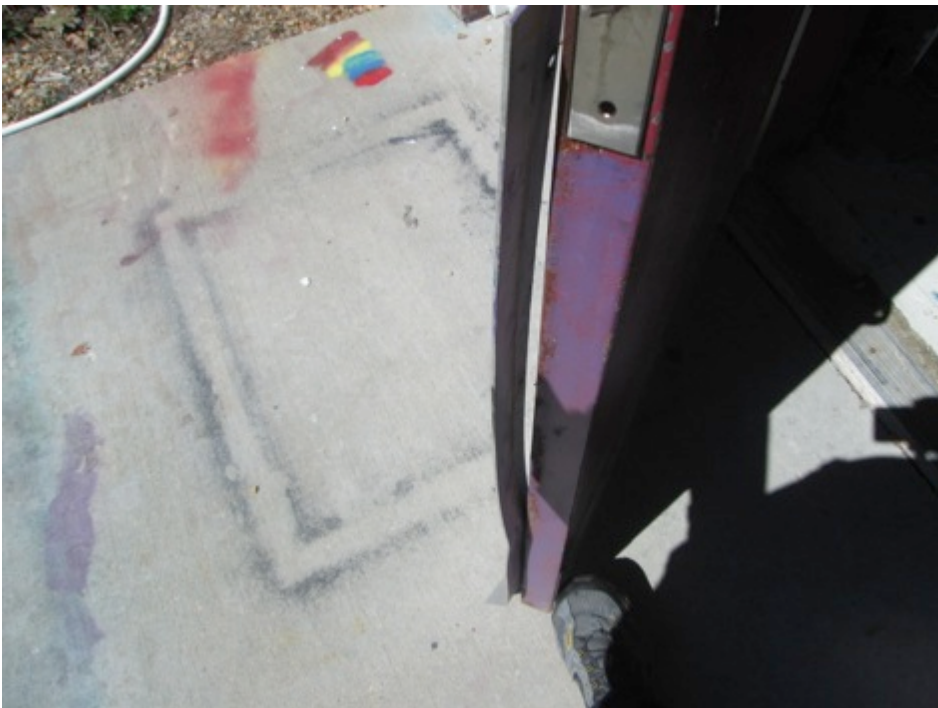
Photo No. 26

Typical damaged/deteriorated weather stripping.

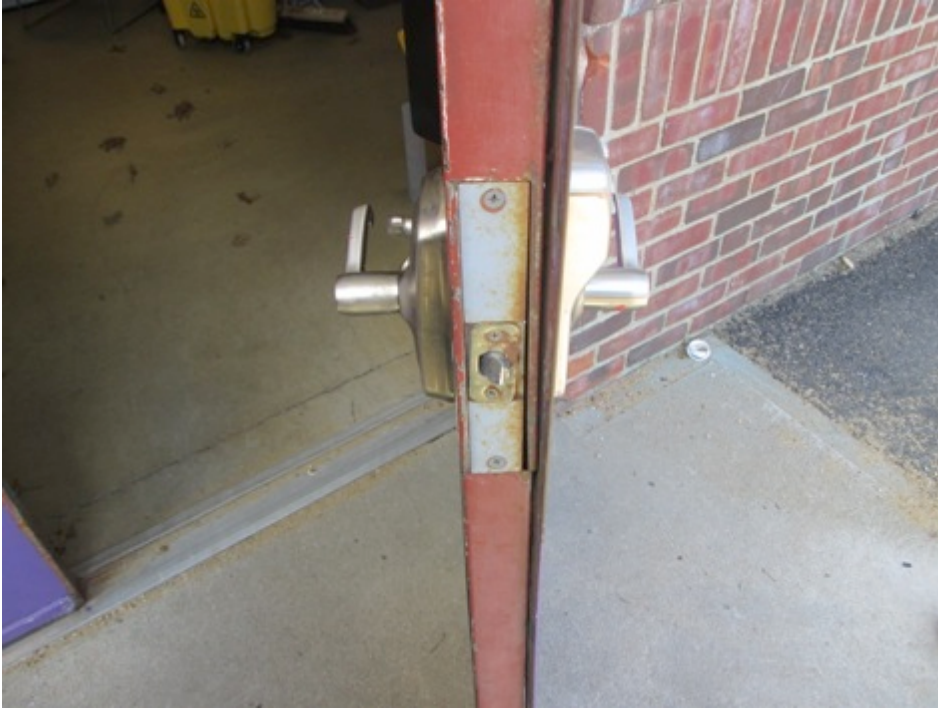
Photo No. 27

Residential quality door latch in commercial application.

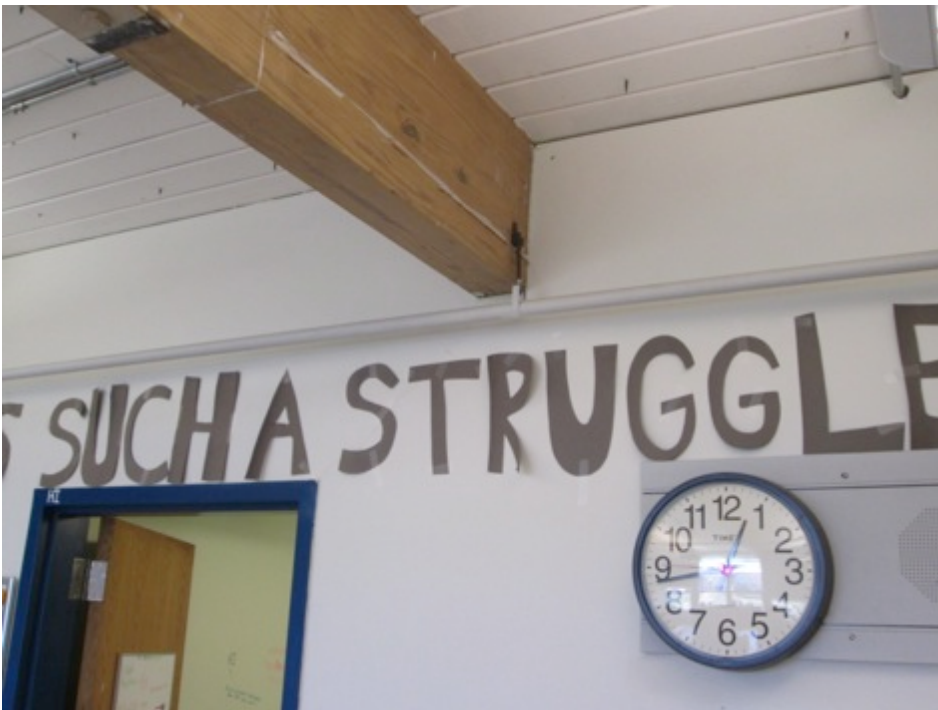
Photo No. 28

Although not a part of this investigation but worthy of mention is the condition of interior finishes in rooms 111 and 113. There is a partition separating these areas that was installed after the main structure was completed. The teacher that occupies this space stated that gypsum wallboard had cracked during this past winter's heavy snowfall and this cracking has dissipated. It is clear that the existing roof structure settled under the snow load and some of the stress was taken up by the newer partition. The newer partition was not intended to support the load and had cracked. This occurrence is not considered unusual or a safety concern and will probably not repeat itself until the next truly heavy snow accumulation.

Cracks in this non-load bearing wall appeared during heavy roof snow loading but these cracks have dissipated.
