**Martha's Vineyard
Regional High School
Vineyard Haven, MA**

HVAC Systems Evaluation

**BLW Engineers, Inc.
311 Great Road
P.O. Box 1551
Littleton, MA 01460
12 June 2015**

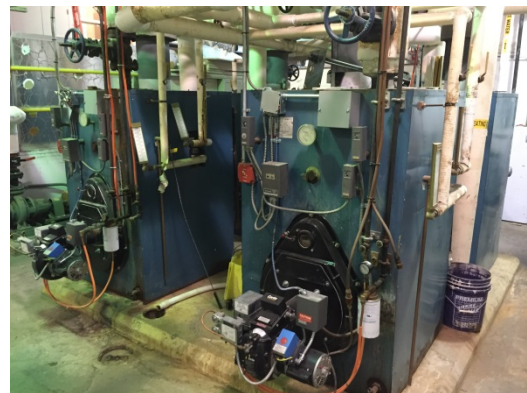
1957 Building Boilers

The boilers are manually controlled and not provided with a reset schedule based on outdoor air temperature leading to space overheating in several areas of the building due to ineffectual or inoperable controls; the

boilers should be provided with a control system that provides for lead/lag operation and hot water reset based on outdoor air temperature.

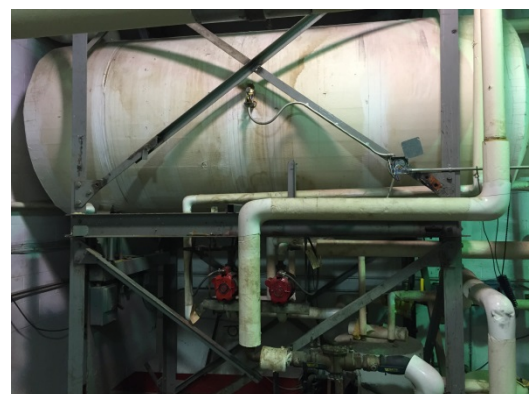
1957 Building Indirect Domestic Hot Water Tank

Due to the significant downsizing of the boilers in the original building, restoring mechanical ventilation to their original design levels, the existing domestic hot water system should be removed from the hot water boilers to provide additional heating capacity to the building and be replaced with a separate oil fired, storage type hot water heating system.

1. Restore existing ventilation to the building unit ventilators including removing existing domestic hot water system from boiler hot water systems by providing two new oil fired, storage type domestic hot water system, cleaning/flushing piping systems and replacement of existing hot water distribution pumps (8 total) with pumps provided with adequate flow and pressure capacity for the systems which they serve.
ECC: \$150,000.00

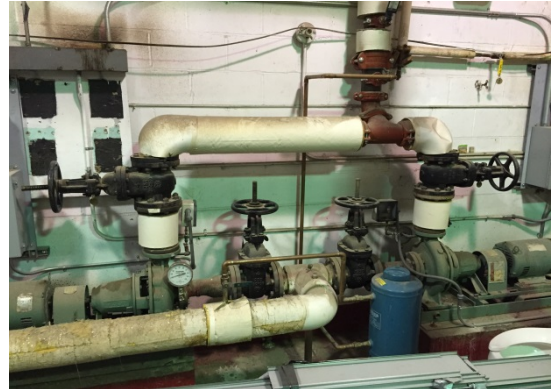
1957 Building Hot Water Pumps

At some point, the pumps were provided with variable speed drives controlled by return water temperature. Due to the unit ventilators with face/bypass dampers, air handling equipment with 3-way control valves, etc. this methodology is flawed since the water flow can't be properly controlled and will not allow for proper heating of the school; the pump variable speed drives control needs to be changed to differential pressure between the supply and return mains of each pumping system to properly control flow.

6. Providing differential pressure controls for hot water pumping systems. ECC: \$ 10,000.00
7. Providing boiler lead/lag operation and hot water temperature reset

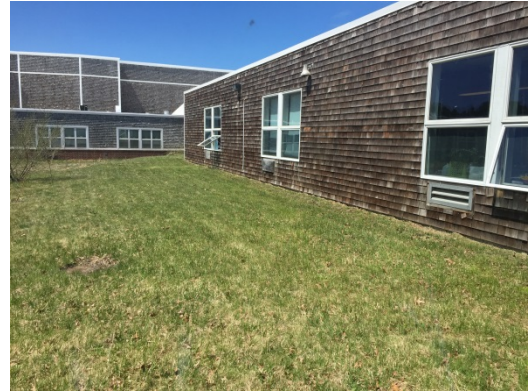
Covered Unit Ventilator Outdoor Intake Louvers

At some point, the classroom unit ventilator intake louvers were boarded closed, eliminating all mechanical ventilation to the classrooms.

The current mechanical ventilation to the school is deficient; even restoring the former ventilation capabilities to the classroom unit ventilators will not provide current code ventilation requirements and also reintroduces the probability of coil freeze failures.

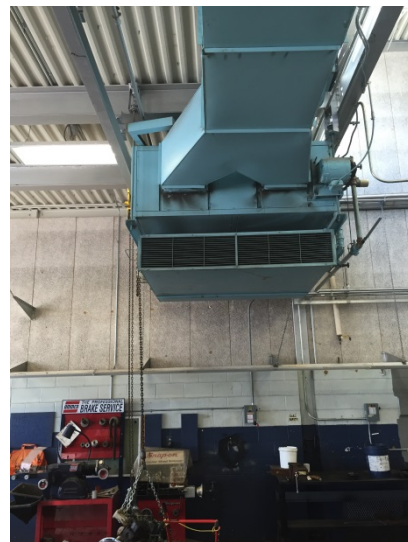
Automotive HV Unit (Inoperable)

The Automotive Shop heating and ventilating unit interlocked with the automotive exhaust system needs to be replaced with a new unit to provide proper space environment in accordance with applicable design standards.

2. Replace unit ventilators including DDC controls, sized for future capacity of full air conditioning and ventilation.
ECC: \$325,000.00
3. Provide equipment and ventilation upgrades to the carpentry shop, automotive shop, sculpture and culinary arts.
ECC: \$100,000.00

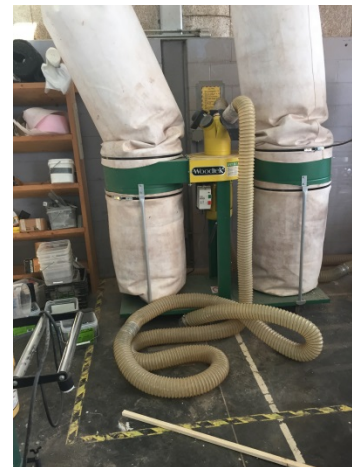
Dust Collector

The Carpentry Shop heating and ventilating unit interlocked with the dust collector exhaust system needs to be replaced with a new unit to provide proper space environment in accordance with applicable design standards.

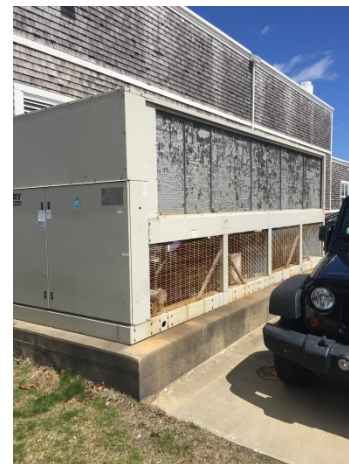
Abandoned Chiller

The two new chillers were installed on their concrete equipment pads but never provided with the interconnecting piping from their installed location into the building and the classroom unit ventilators in F Wing were never replaced.

The chillers were installed on the concrete pads but never interconnected to the building piping systems; at this point, the chillers should be considered inoperable.

1. Replacement of the entire HVAC system including mechanical equipment, revisions to the existing piping distribution system, automatic temperature controls and electrical to support the mechanical equipment.
ECC: \$4,200,00.00
2. Addition of air conditioning to the existing two pipe heating system.
ECC: \$600,000.00
