Martha's Vineyard **Regional High School** Oak Bluffs, Massachusetts

TRACK INVESTIGATION SUMMARY REPORT

May 25, 2011 UPDATED March 27, 2015

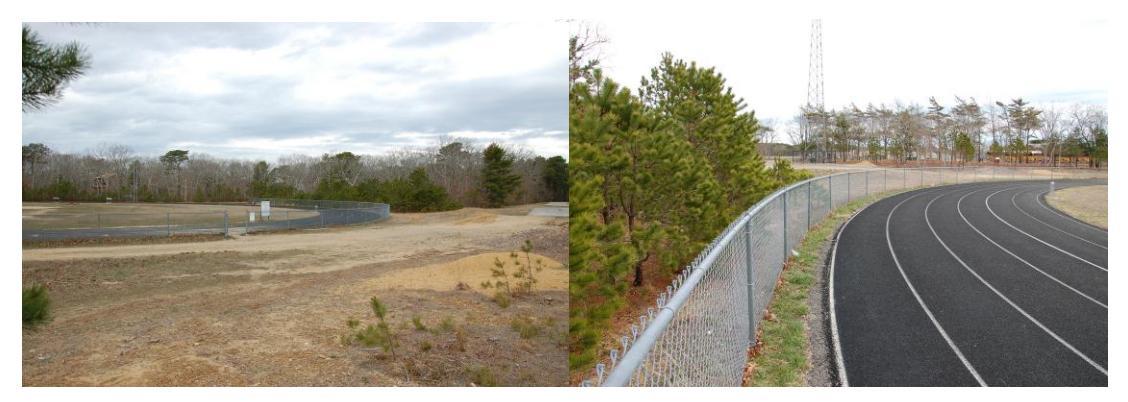
Photos 1 and 2: Access from high school. Limit of pavement and track at the north end of the track.

The previous conversion to the 400 meter length is located at the south end of the track. Several areas of running lanes 1 and 6 are in close proximity [0-3"] of the edge of the pavement and track surfacing. Along the north turn one, the fence is located approximately 2' from the outside lane line.

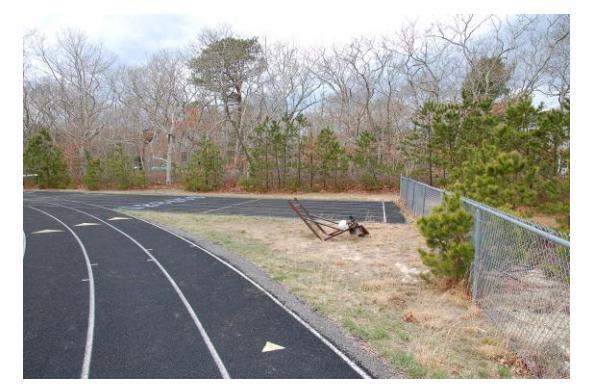
The track has one single chute, located in the northwest corner of the facility. This location requires the finish line and all sprint events to be run on the west straight, away from parking and general access.

Photo 3: Chute at northwest end of track

In addition, the reconstructed jump runway outside of the track allows for the expansion of the interior field for multisport play. The complete reconstruction of the track would allow the relocation of the chute from the west to the east side of the track, providing improved access and viewing for spectators. Also, the expansion of the sprint lanes from 6 to 8 lanes could be accomplished at this time.

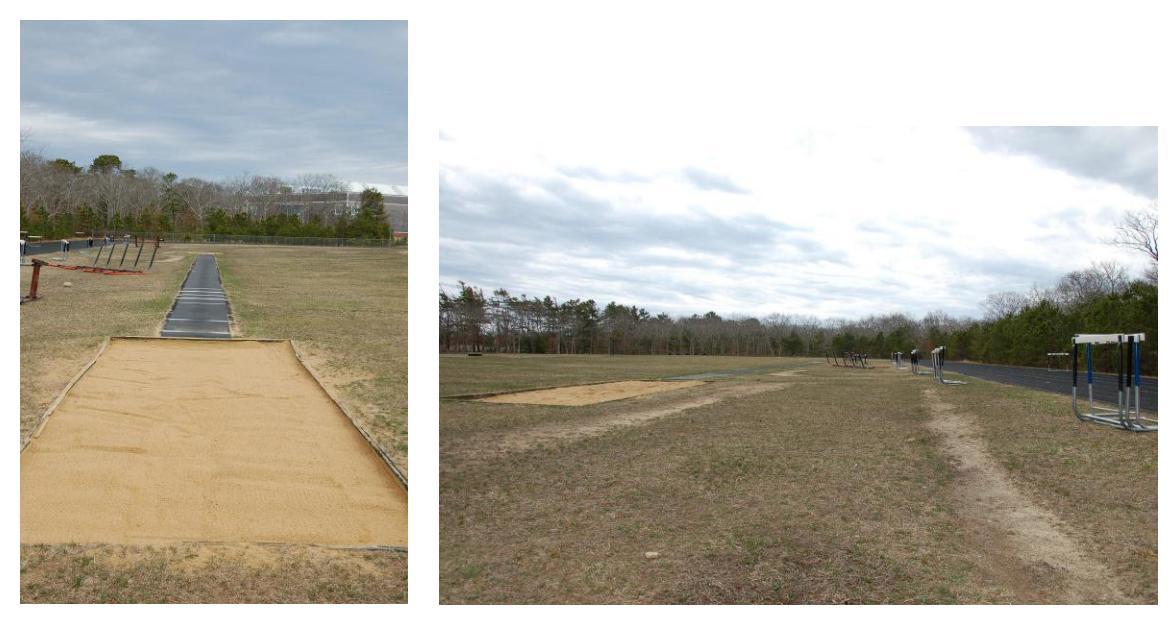
Long triple jump pit is oriented in a north south direction, located on the west side of the track. Jump pits are located at both ends of the runway. The location of the runway and jump pits [approximately 20' into the field area] compromises the effective playing width of the athletic field.

Photos 4 and 5: Long and Triple Jump Landing pit and location along west straight

[loamy sand] should be provided to ensure a minimum of 6"–8" depth of topsoil in all athletic field areas. As part of this field reconstruction, the relocation and construction of a new concrete long jump runway/pit outside of the turf field is recommended to permit wider field dimensions and more multi-sport capability of the field.

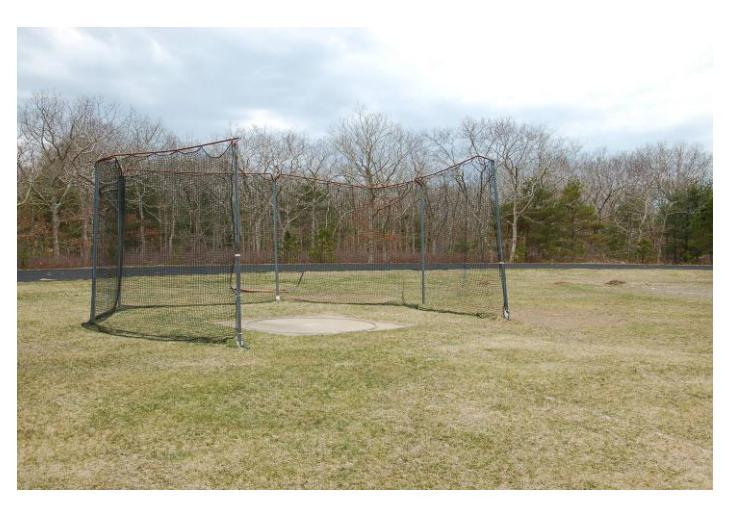
Discus throwing area is located at the south end of the track, throwing onto the field. Shot landing area is also located at the south end of the facility. Javelin events are conducted across the street; this location is not a meet management problem, according to the Track Coach.

Photo 6: Discus throwing area

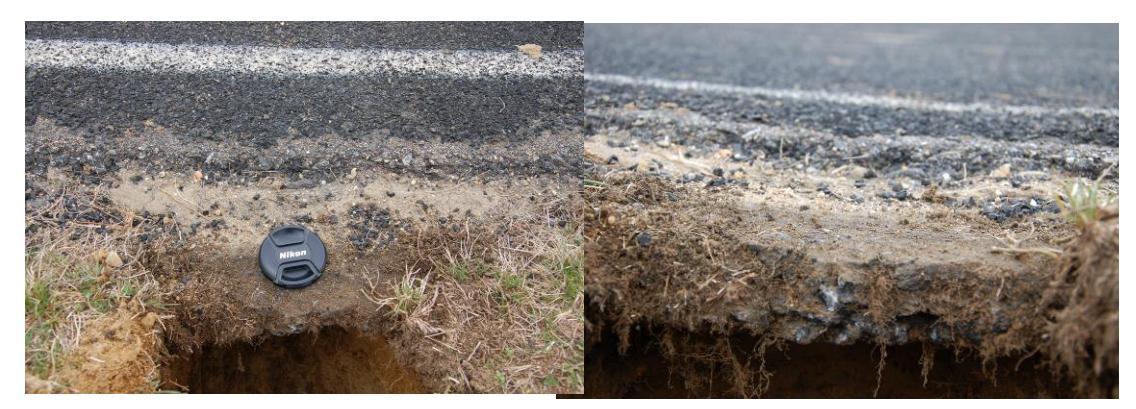
The track surfacing is again at the end of its useful life and the pavement below exhibits cracking and other age related issues. The pavement section appears to include a minimal amount of stone base material [2-4"], an initial base course of bituminous concrete $[1\frac{1}{2}$ " - 2" thickness], with a topping course of bituminous pavement $[1 - 1\frac{1}{2}$ " thickness]. The bituminous pavement has been surfaced with a rubberized granulated track material, currently approximately $\frac{1}{4} - \frac{1}{2}$ " in thickness. Runners are now running over uneven and inconsistent surfaces.

Photos 7 and 8: Track Pavement Edge Condition and Section

- -Remove existing track surfacing material.
- -Mill & Pulverize all existing bituminous pavements, incorporating the pulverized material with the existing aggregate base material.
- -Install perimeter curb on track and continuous trench drain on the interior edge of the track.
- -Install drywell structures within field to accept drainage from trench drains.
- -Construct new Paved and surfaced jumping runways and high jump areas outside of the field at southeast side of the track.
- -Expand high jump area.
- -Pave new track surface, including relocation of the chute to the east side of the track.
- -Apply new polyurethane based, paved mat structural spray track surface to entire running surface and jump runways.

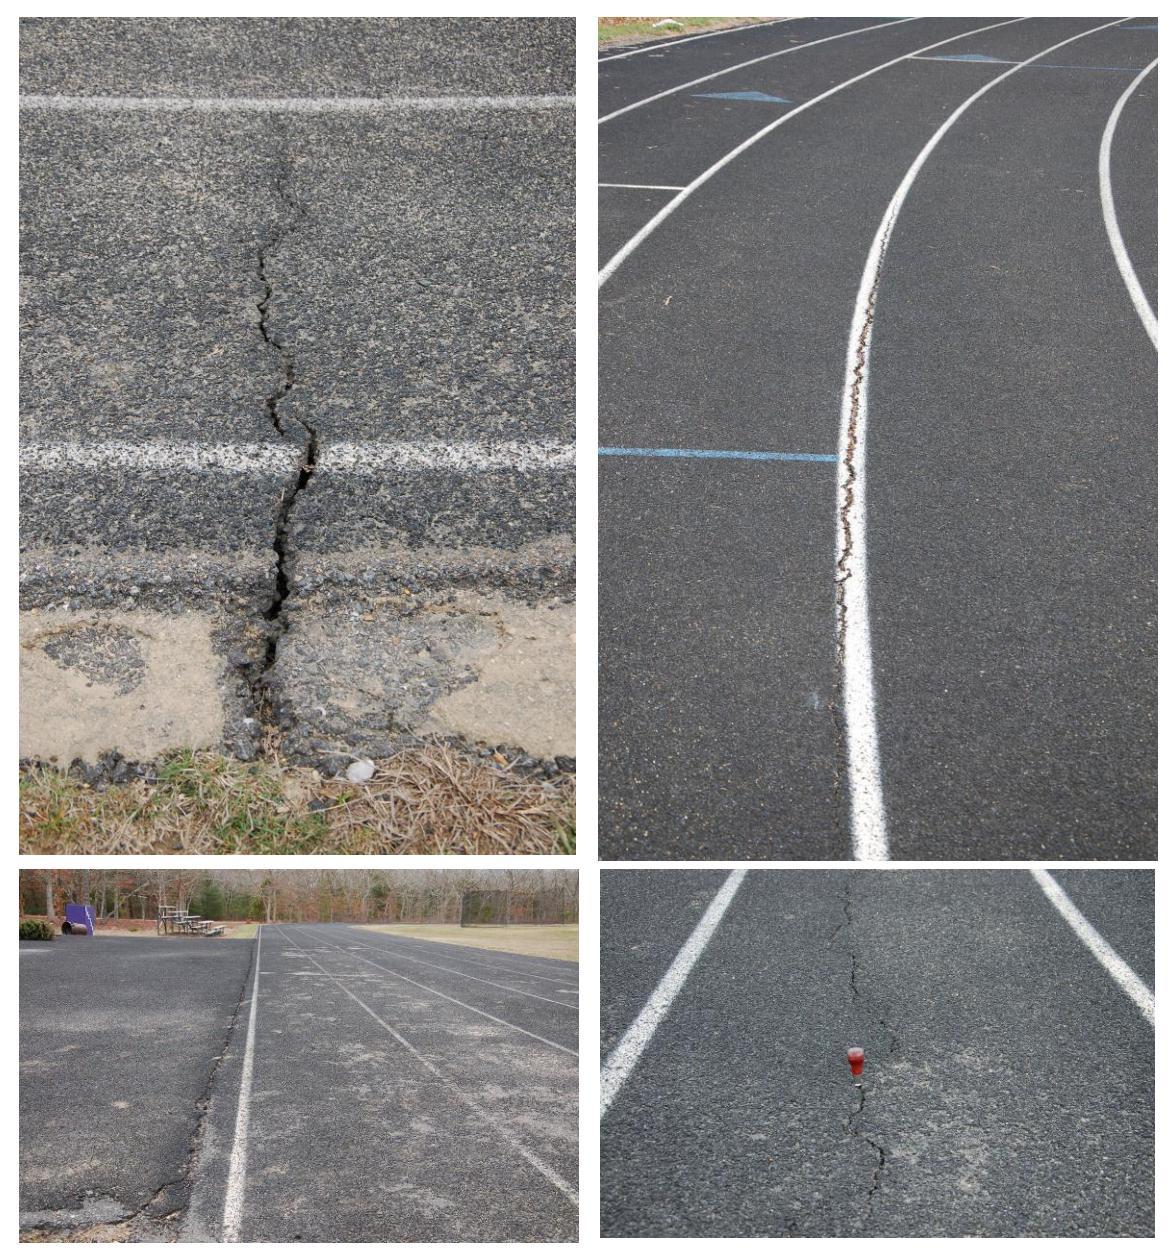
In addition, there are numerous cracks and pavement deterioration present in many portions of the bituminous pavement. A concentration of these cracks is located in the north and east sections of the track oval. The majority of cracks in the pavement are longitudinal, running parallel to lane lines; suggesting a reflection of paving operations. However, there are some cracks located in a transverse, 'headseam' orientation. While some of the cracks appear to be present only in the top course of the bituminous concrete; other cracks are full depth pavement failures [both top and base course of bituminous].

Photos 9 - 12: Track Pavement Cracks / Failures

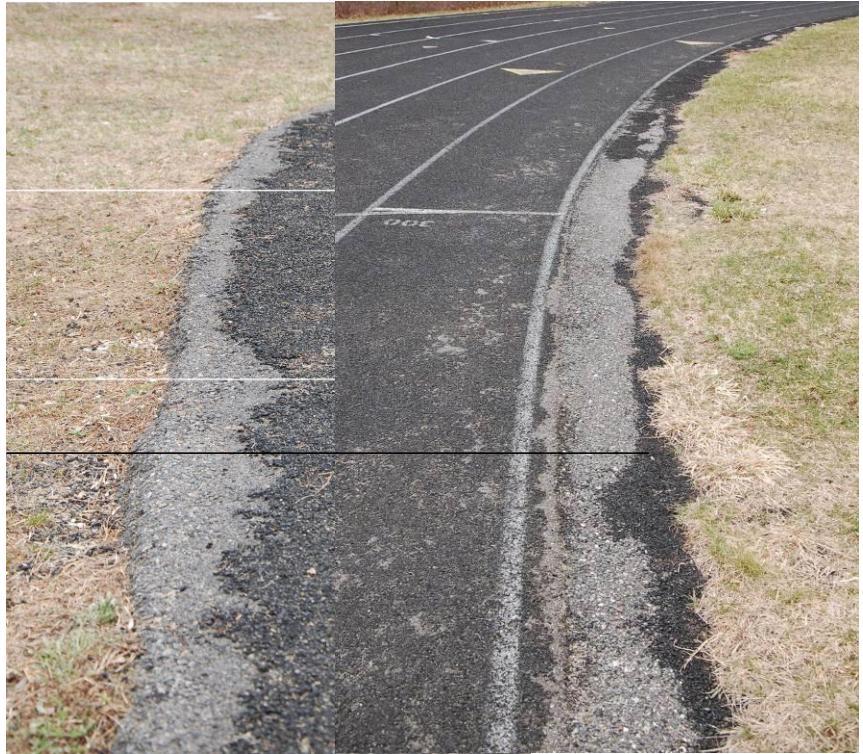
There are no perimeter curbs at the limit of the track surface, contributing to an existing edge condition that is unraveling. This condition is occurring in many sections of the track, and is particularly apparent at the south Turn One, and the east high jump area.

Photos 13 and 14: Typical Track Pavement Edge Conditions

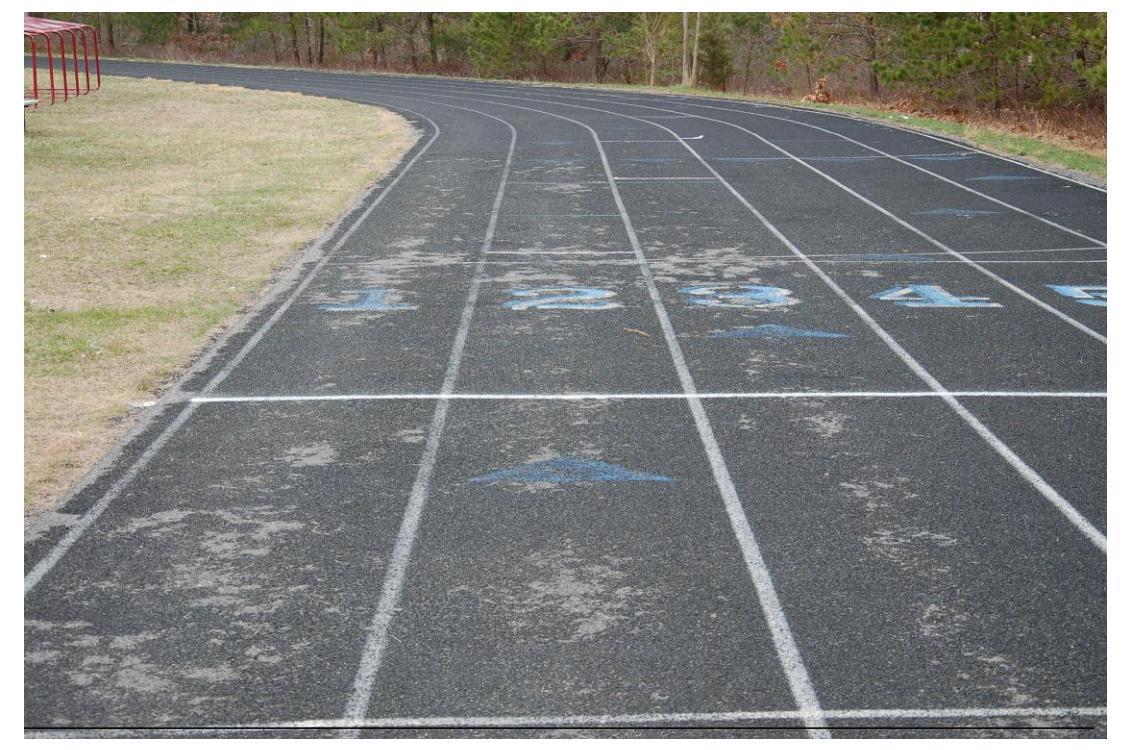
Photo 15: General Track Pavement Condition, illustrating bare / inconsistent running surfaces

CHA Sports recommendation is to completely remove and reconstruct the entire running track, providing MVRHS with a new track facility. Work would include the following steps:

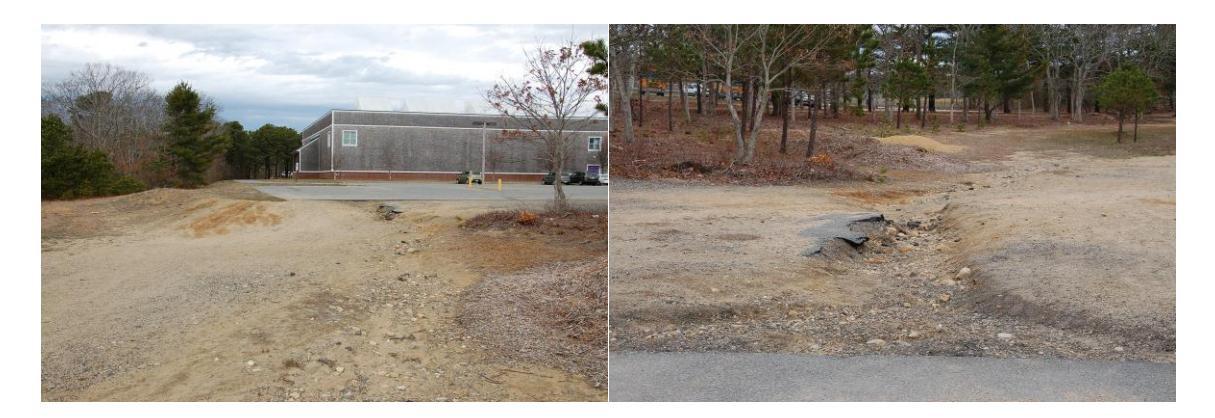
Photos 16 and 17: Erosion off the athletic parking area towards the track

Code mandated access to the facility should be provided, including construction of a paved maintenance access and drive from the north parking area to the track and the existing storage structures. In addition to providing proper access, a paved drive will assist in keeping sediment and debris off of the track surface, and will assist in the construction of the drainage swale to the east structure.

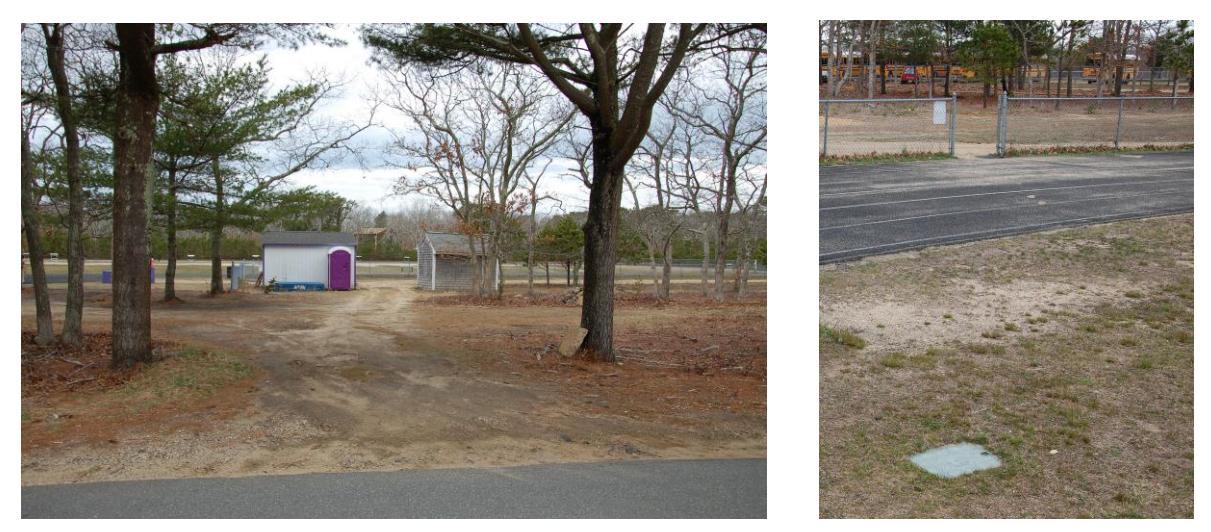
Access and parking capacity is limited to the existing athletic parking area at the high school. There is no paved accessible path to the track precinct. Lack of stable access drive pavement material contributes to sand and debris on the track, which accelerates the deterioration of the synthetic track surface.

Photos 18 - 19: Unprotected vehicular access and primary entry to track facility from High School

Ad hoc informal parking occurs adjacent to the storage facilities. The track facility is currently unprotected from vehicles from the street and from all-terrain vehicles from adjacent residential neighborhoods.

- 2. Perimeter Fencing and Vehicular Protection
 - Gates and fencing should be provided to protect the track from unauthorized use and vehicles. Fencing immediately adjacent to the track should be held a minimum of 1 meter away from the outside running lane. Additional fencing or guard rails should be considered along the track west straightaway, south turn, and along the utility corridor to protect vehicles, bikes, etc. from entering the facility. Fencing systems should be designed to permit ongoing general community use. Fencing priced is 42" high, 9 gage, black vinyl coated fence.

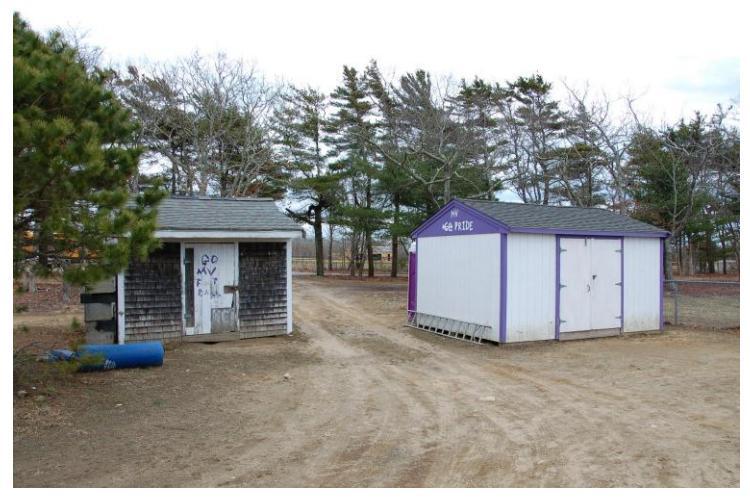
Storage of equipment occurs on the east side of the track facility in two wooden structures. Bleachers/seating is limited to one freestanding unit adjacent to the high jump.

Photo 20: Storage Facilities

Additional support parking area [approximately 12-15 vehicles] is recommended along the east side of the track to improve maintenance access and handicap parking for the venue. Additional storage facilities could be located immediately adjacent to this new parking area.

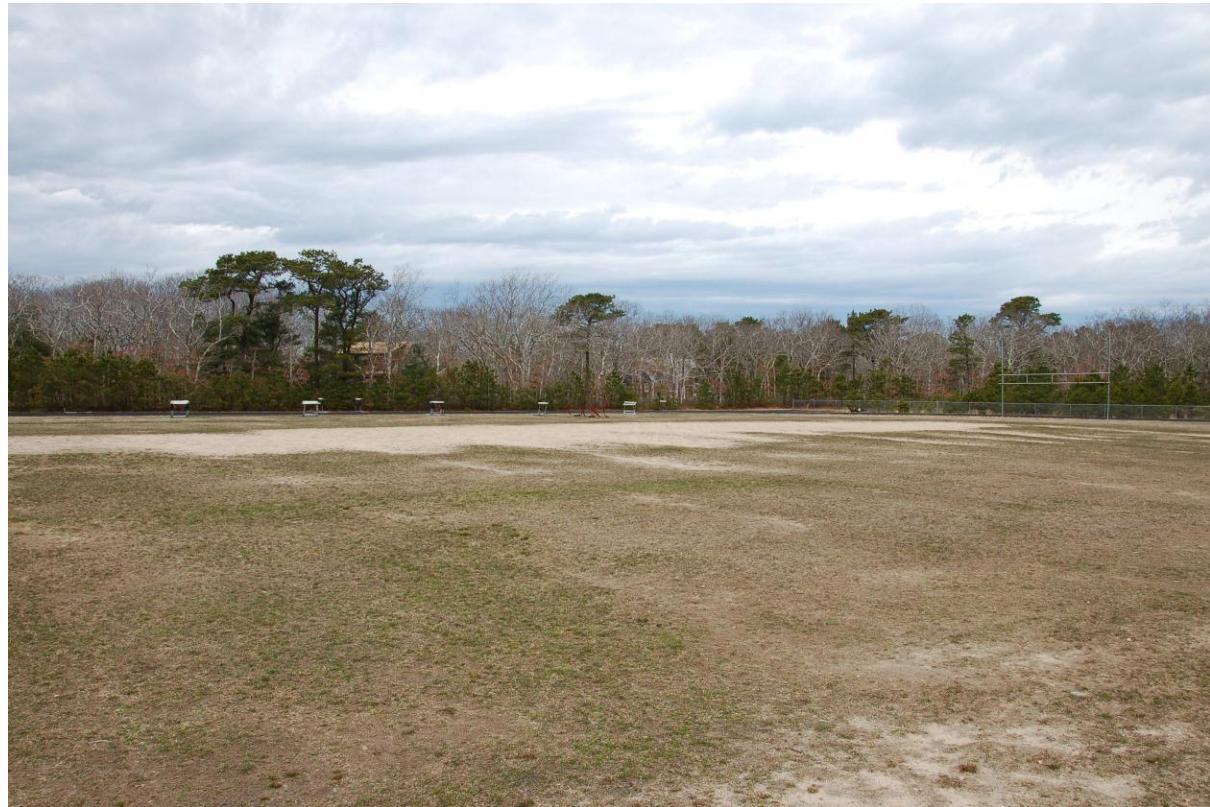
Overall, the condition of the interior playing field is extremely poor, with significant areas of the field that are bare with no turf. It was reported that areas where the turf is in somewhat better condition is where additional topsoil was imported. Little or no topsoil is present in the center portion of the field. Lack of functioning and effective irrigation system further contributes to the poor condition of the field.

There is an excessive, approximately 2' crown to the center of the field from the track pavement. As previously noted, the long and triple jump runway limits the effective playing width of the field

Photo 21: Overall condition of the interior grass playing field

Currently, the existing natural grass athletic field is in extremely poor condition, including significant bare areas, high broadleaf weed content, and shallow root depth. Primary causes appear to be a lack of adequate irrigation system capacity and shallow depth of topsoil.

The existing 1" irrigation supply to the field from the north parking area should be abandoned, and a new water supply should be constructed from the varsity baseball field water supply well. Extension of the water service from this area to the track will provide improved and adequate irrigation to the field. Irrigation controls could be located in the storage facilities along the east straightaway.

The existing field should be regraded to reduce the existing crown on the field to approximately 1.25%. As part of the regrading effort, additional borrow topsoil

The field should be reseeded or sodded, with a blend of hybrid fescue/rye/bluegrass to support athletic events. If the field is seeded the field will need to be allowed to develop for a minimum of two full growing seasons before scheduling any play on the field. If the field is sodded in the early fall it will be ready for use the following spring
