HUNTRESS ASSOCIATES
Landscape Architecture & Land Planning

January 31, 2019

Re: Martha's Vineyard Regional High School – Athletic Field Master Plan

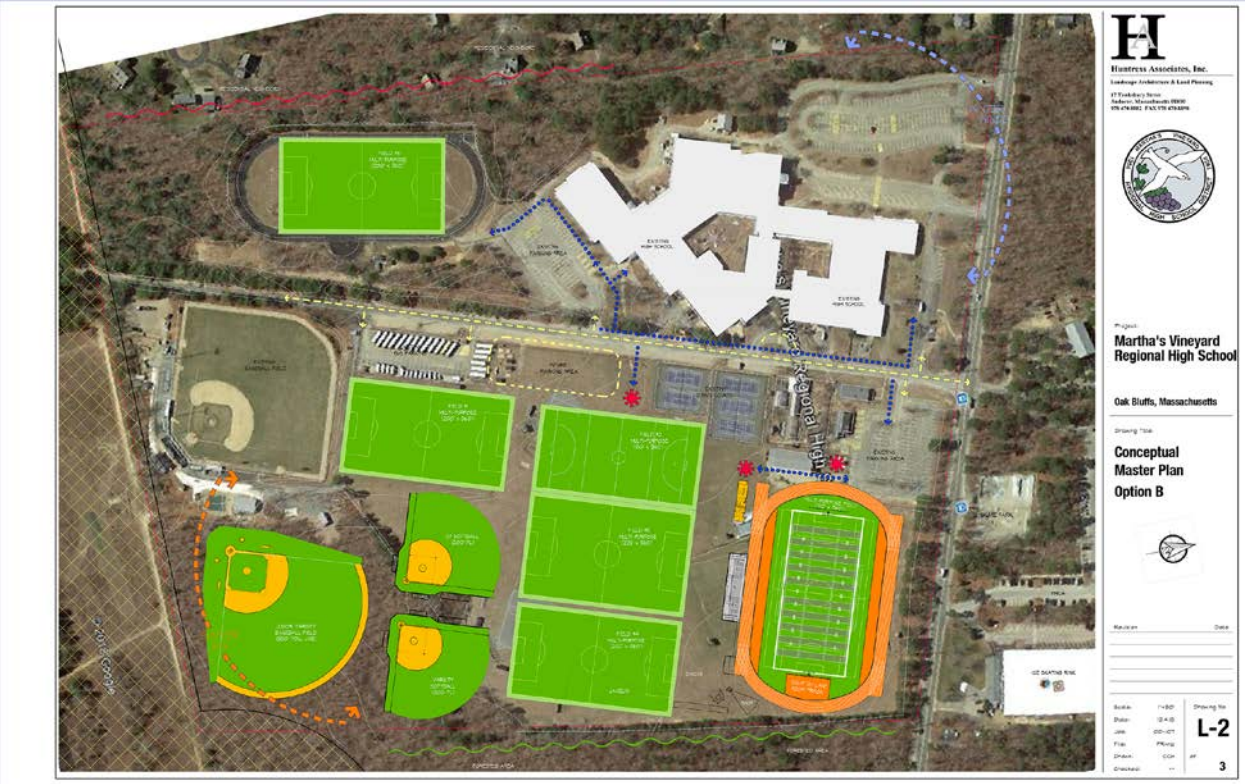
Figure 13 – Athletic Field Master Plan – Option B

The above plan rearranges the athletic field program to bring the track and field forward to front of the site. The changes to this plan include moving softball from the old track and field location to provide for two dedicated softball fields. This plans also shifts the JV baseball field a bit further south. This layout would allow for better softball tournaments and allow all baseball and softball fields to share the facilities associated with the MV Sharks Baseball Field. The new track and field facility is currently shown with a new sports lighting system, and 1000 seat grandstand and pressbox.

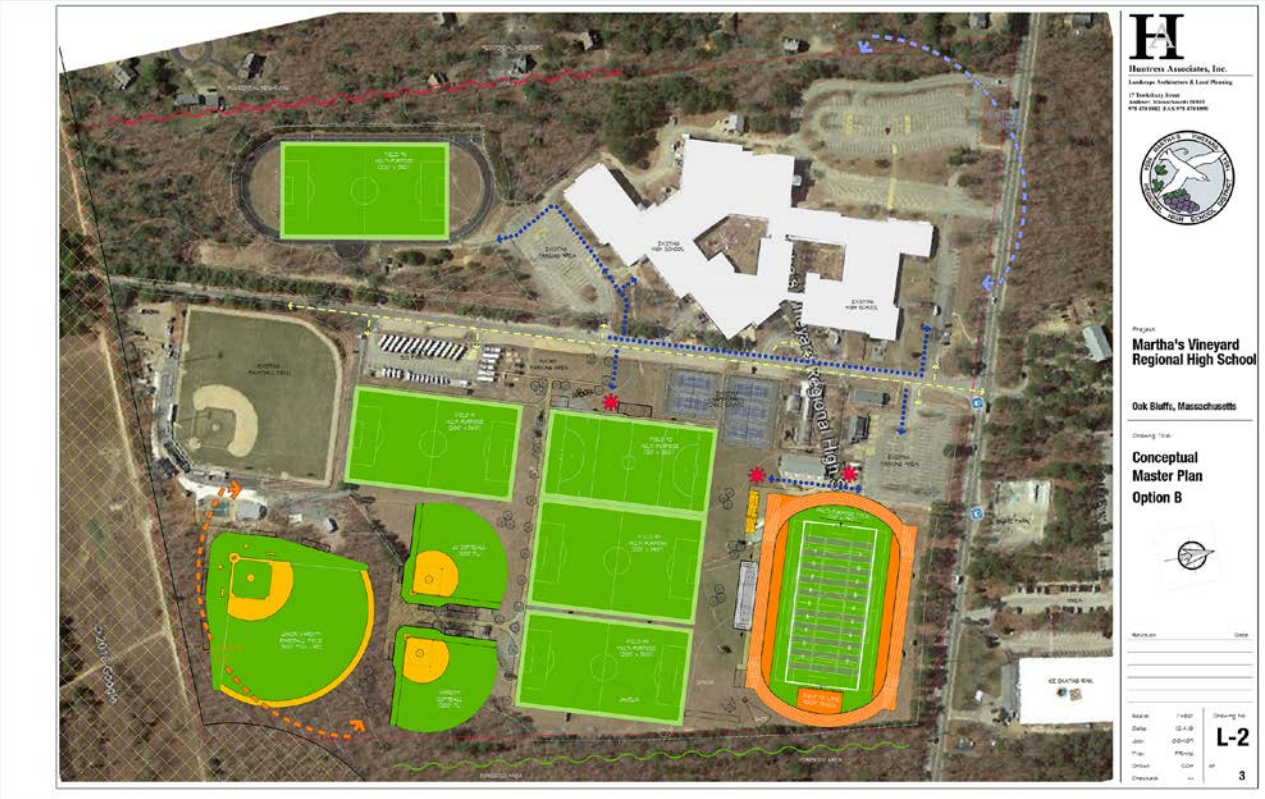
Figure 15 – Athletic Field Master plan - Preferred Option (Option B)

This option shows a 400m running track in what is called the international style or "broken-back" configuration. In this layout the straight-aways are shortened and the radius curves are elongated. This helps to fit the 400m track dimensions into the space available at MVRHS, but also provides for a very wide athletic field. The total width of the athletic field is approximately 232' across, allowing for a 220' wide soccer field and easily accommodating all other sports.

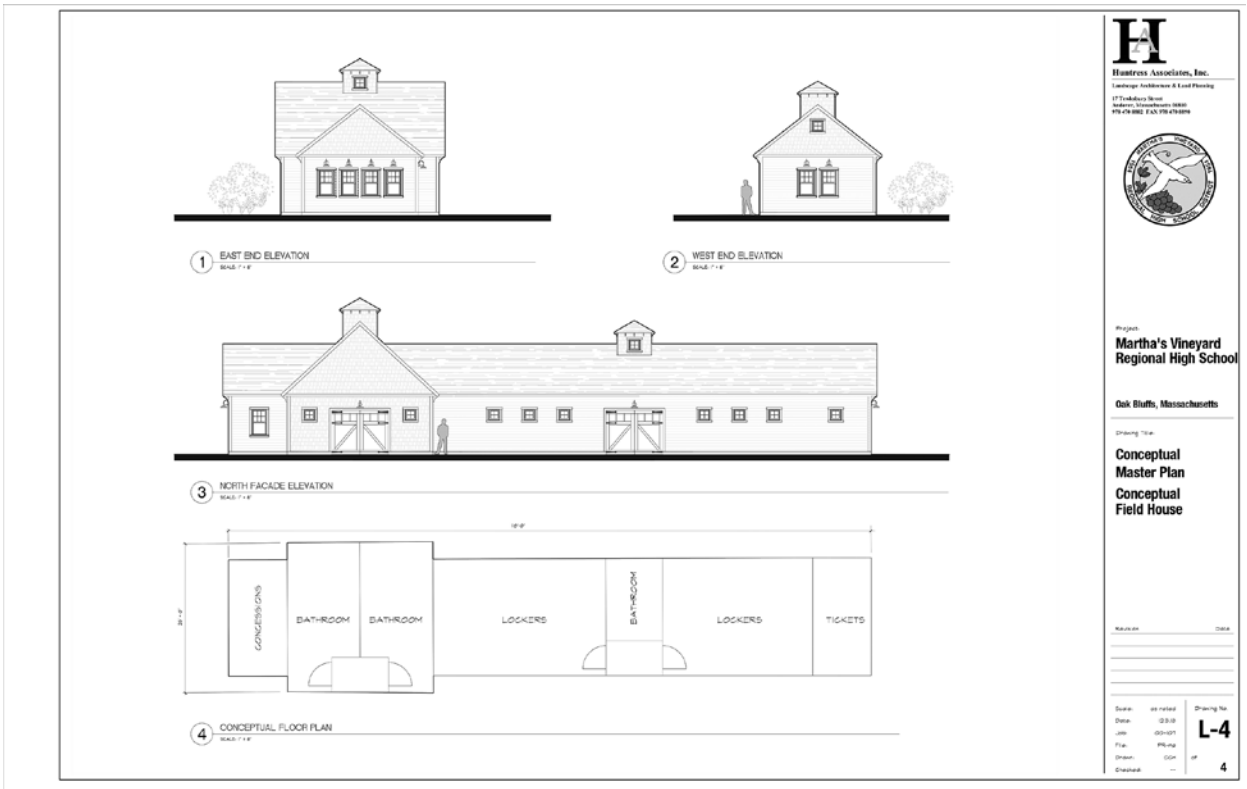
Figure 16 – Athletic Field Master Plan – Conceptual Field House Plans

At the request of the committee, we have also added a conceptual plan for the proposed fieldhouse. This field house layout plan accommodates two (2) locker rooms, ticket booth, concessions and bathroom facilities. The proposed fieldhouse contains approximately 3000 square feet of area on a single level and would have enough space to accommodate two football teams during half-time and provide enough bathroom space for the proposed 1000 seat grandstand structure. The proposed building is located on the southwest corner of the track and field. Please refer to *Figures 15 and 16* for additional information.

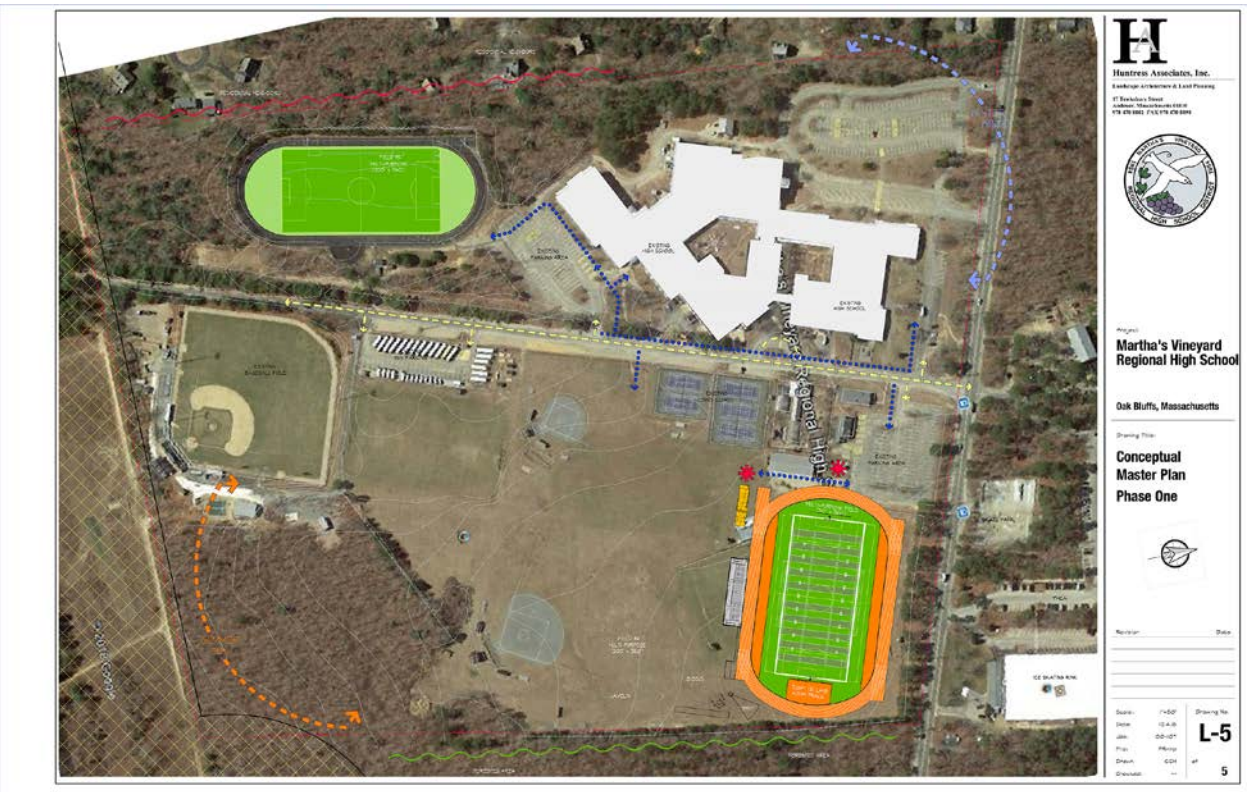
Figure 16(a) - Preferred Alternative – Phase One

The above Phase One layout looks to focus on the construction of the 400m running track, multi-purpose athletic field, sports lights, 1000 seat grandstand, pressbox, field house and associated site improvements. At the same time, we would recommend a full reconstruction of the existing natural grass athletic field within the existing track. As a cost saving measure, we have not removed the existing track at this time, allow it to stay in place for school/community use and t serve as a spectator viewing area for events on the infield.
